Subject: Voluntary Emissions Recall Report for Toyota Safety Recall Campaign 20TA10 on Certain Toyota 2013-2015 Model Year (MY) Prius, 2014-2017MY Prius V Vehicles Inverter and CARB Approval Letter #F-2020-067 dated July 16, 2020

Toyota launched the subject campaign on July 24, 2020. Approximately 266,637 total units are affected by this campaign. The 20TA10 instructs any authorized Toyota dealer to update the hybrid system software FREE OF CHARGE. For customer satisfaction, if the vehicle has experienced an inverter failure with certain hybrid system faults related to this condition, the inverter assembly will be repaired or replaced FREE OF CHARGE. The involved vehicles were designed to enter a failsafe driving mode in response to certain hybrid system faults. Toyota has found that in rare situations, the vehicle may not enter a fail-safe driving mode as intended. If this occurs, the vehicle could lose power and stall. While power steering and braking would remain operational, a vehicle stall while driving at higher speeds could increase the risk of a crash. The subject vehicles were not involved in Safety Recall J0V because they were originally equipped with the E0E/F0R version

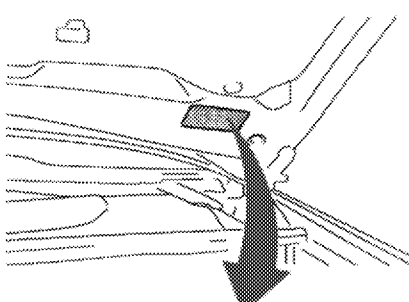
- Fill out the label.
- Affix the label to the under-side of the hood.

TOYOTA MOTOR CORPORATION
AUTHORIZED MODIFICATIONS
 THE FOLLOWING MODIFICATIONS HAVE BEEN MADE:

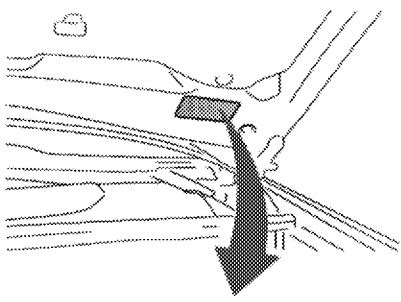
- Fill out the label.
- Affix the label to the under-side of the hood.

TOYOTA MOTOR CORPORATION
AUTHORIZED MODIFICATIONS
THE FOLLOWING MODIFICATIONS HAVE BEEN MADE:
